## **HVS-NORDIC**

**The activity of the first period in Finland 1997 - 1999**

**21/2000**

**Finnish National  
Road Administration**

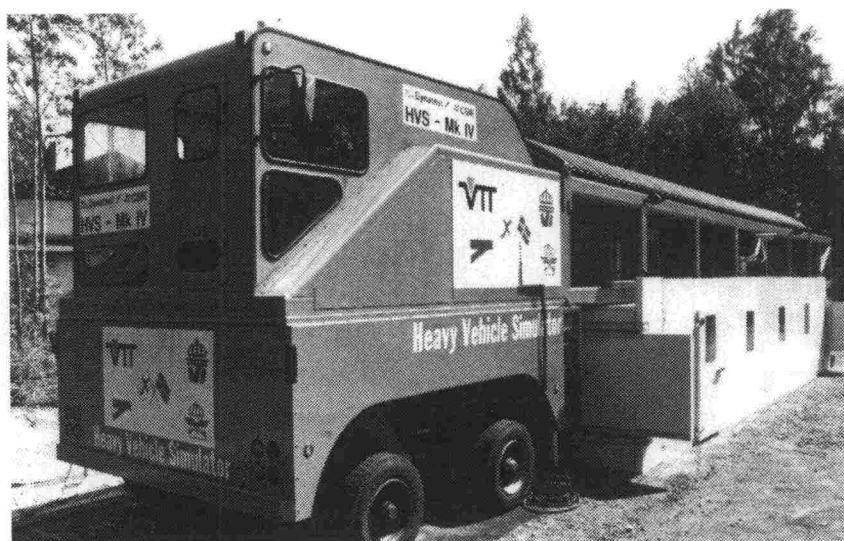
The machine is called HVS-NORDIC. The HVS Mark IV is a mobile full-scale accelerated pavement-testing facility (Figure 1), whose loading is linear. It can be run over a short distance by itself at walking speed, in practice only at the same test site. It can be moved as a semi-trailer over longer distances to other test areas or to VTI in Sweden. Since it has steering wheels, it can turn even relatively sharp corners, in spite of its long length. Its highway speed is 50 km/h, and special permits are needed.

Figure 1. HVS-NORDIC accelerated testing facility.

The HVS-NORDIC has a heating/cooling system and thus temperature can be held constant. The air temperature inside the heating/cooling box is
